Fire Station #1 Assessment and Capital Plan

A. Building Description

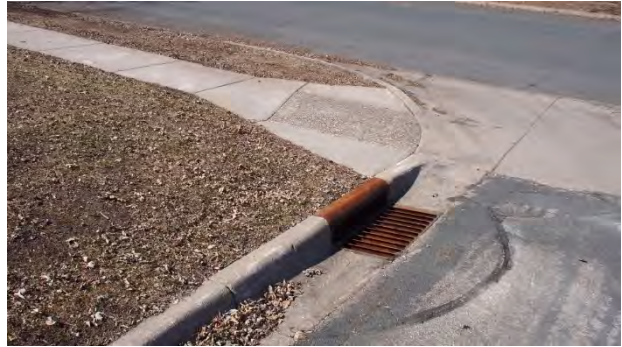
Figure B.2.3

3. The concrete response apron is in poor condition with major cracking and spalling. We estimate replacement will be critical within 10 years.
 4. The concrete return apron is in good condition.

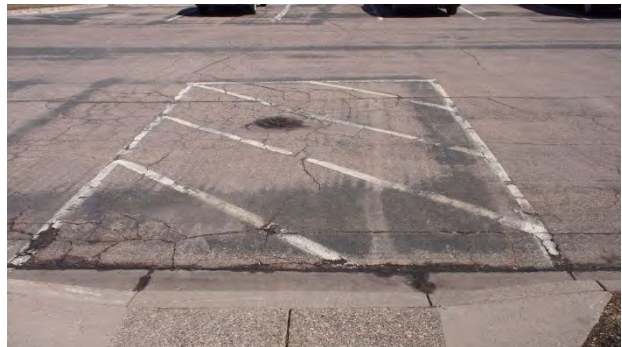
Figure B.3.1a

7. The concrete parking lot entry on the west side is in poor condition and should be replaced.
 8. The concrete sidewalks are in generally good condition.

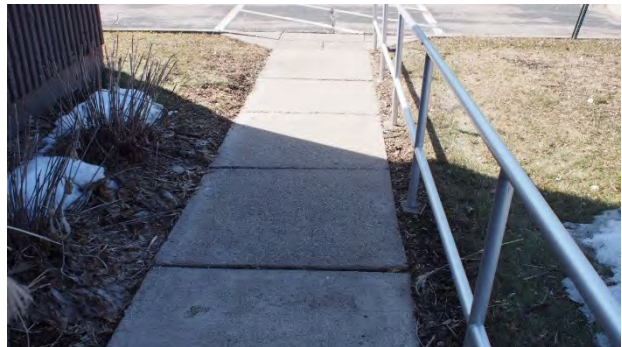
Figure B.3.8.1

- (1) The sidewalk between the Senior Center entrance and the west parking area has heaved/settled and should be replaced.
4. Landscaping and Site Elements

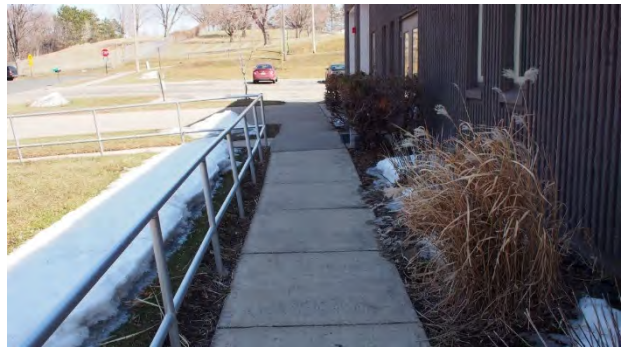
Figure B.4.3a

1. Plantings were not observed due to the time of year.
 2. The flagpole is in good condition.
 3. The handrails along the sidewalks are leaning and should be removed and re-set in new foundations.

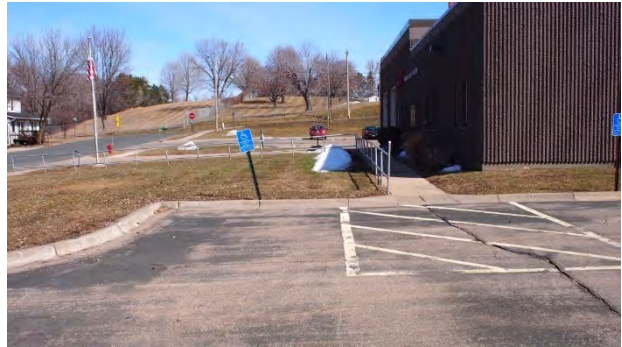
Figure B.4.4a

4. The no parking and reserved parking sign poles are broken off or leaning and should be removed and re-set with new concrete foundations.
5. Water service entrance was not observed.

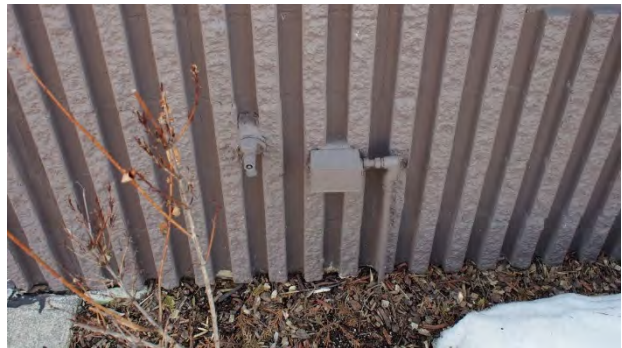
Figure D.1.3

3. The piping and conduit penetrations at the fluted block are not tightly sealed. We recommend sealant over the paint.
 4. There are no visible control joints in the block. These cannot be added retroactively, and the lack of such joints increases the likelihood of cracks forming between the blocks and the mortar. We recommend closely monitoring the exterior for micro-cracks that would allow water into the wall.

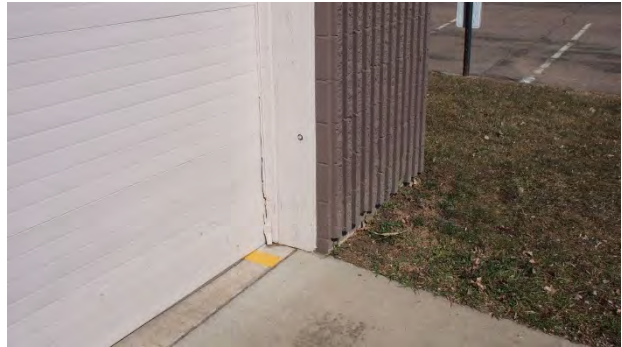
Figure D.2.1.1

2. Windows and Doors
 1. The apparatus doors, springs, and tracks are in good condition.
 - (1) The weatherstripping and bottom seals at the apparatus doors are in poor condition and should be replaced.

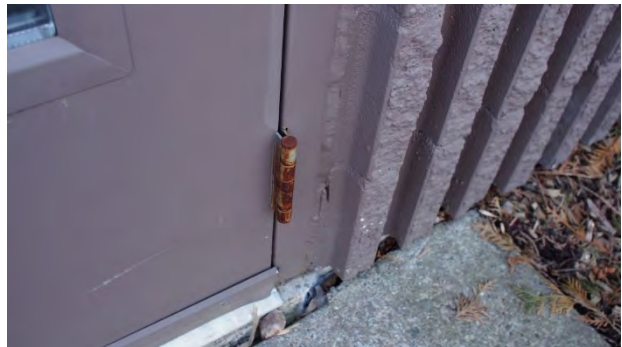
Figure D.2.2.1a

- (1) The hinges are starting to rust. We recommend replacement with non-ferrous hinges.
 - (2) The sealant at the perimeter of the frames is missing in some sections. We recommend removing the existing, painted-over sealant and replacing.

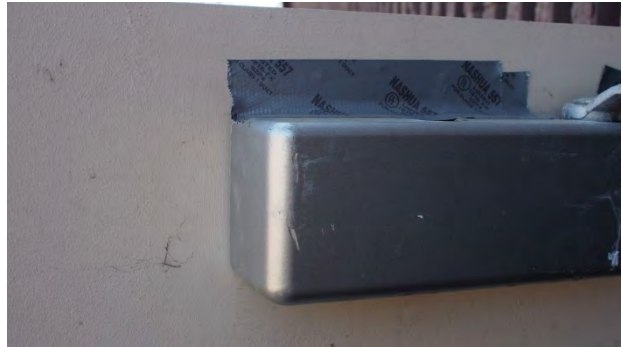
Figure D.2.2.4

- (3) A drip at the head of the north door into the apparatus bays is missing. We recommend adding this piece of hardware to reduce water intrusion.
 - (4) The closer cover at the east door is held on by duct tape. We recommend replacement.

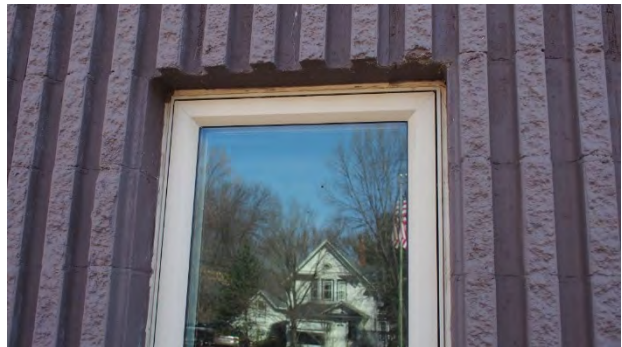
Figure D.2.3.2

- (1) There are horizontal mortar joints at the window sills. We recommend raking these joints back 1/2" and filling with sealant to prevent water from getting into the wall system through cracks between block and mortar.
 - (2) The sealant at the perimeter of the frames is failing in some sections. We recommend replacement.
 - (3) The sill blocks at the northernmost window on the east elevation are cracked. We recommend replacement to prevent water from getting into the wall system.
3. Roof
 1. The roof was inaccessible and was not reviewed.
 2. It was reported that the roof is leaking. We recommend immediate repair.

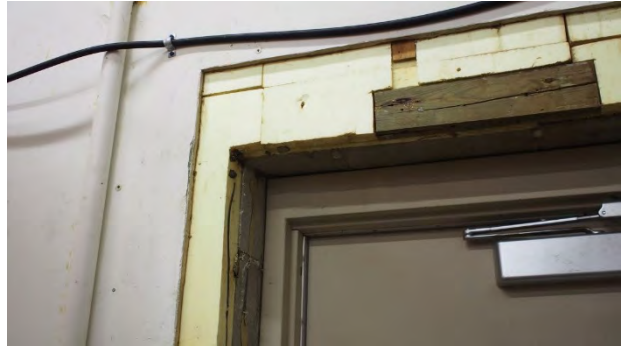
Figure E.2.2.1a

2. Walls
 1. The cement block walls are in generally good condition.
 2. The gypsum board over the exterior walls is in generally good condition.
 - (1) The gypsum board at the south door into the apparatus bays is missing. We recommend replacement.

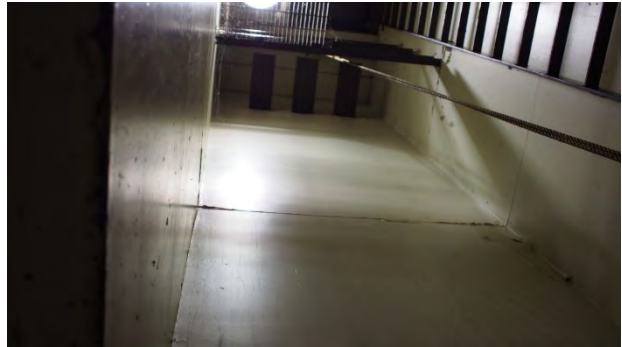
Figure E.2.2.2

- (2) The gypsum board in the hose tower is in poor condition. We recommend removal and replacement with exterior gypsum.
 3. The gypsum board walls on the mezzanine level are unfinished in many areas.

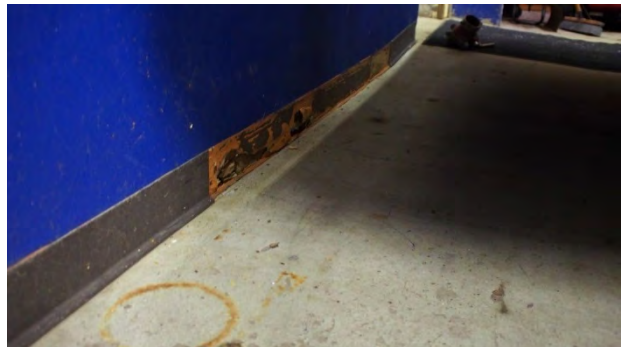
Figure E.2.4

4. The rubber base is missing in some locations. We recommend replacement to protect the gypsum board from damage while washing apparatus.
3. The hollow metal doors and frames are in good condition.

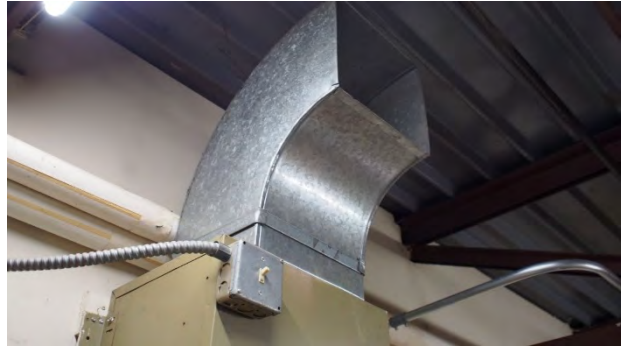
Figure I.5b

4. Exhaust fans in bathrooms are aging and we estimate replaced in the next 5-10 years. Fan operation is interlocked with light switches in bathrooms.
5. Exhaust fan serving PPE storage discharges into mezzanine above. This air needs to be exhausted to the exterior.

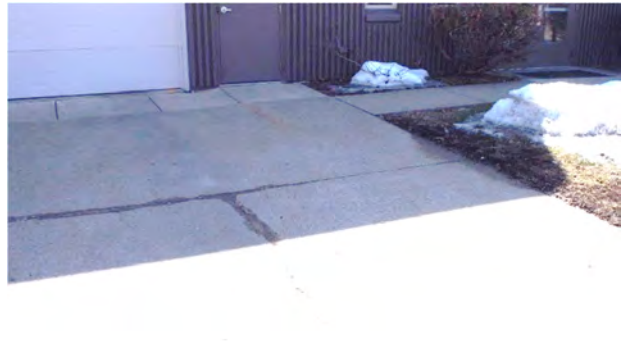
Figure O.2

1. There are no truncated dome detectable warnings where the public sidewalk crosses the apparatus apron or the parking access curb cuts.
2. There are no truncated dome detectable warnings where the site sidewalk crosses the apparatus apron.

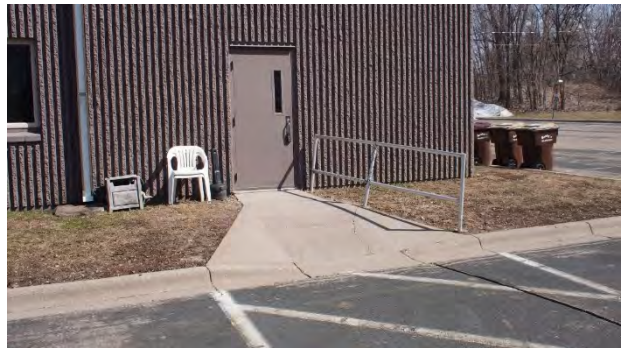
Figure O.3b

3. There are no truncated dome detectable warnings at curb ramps.
4. The accessible parking spaces are not correctly painted.
5. There are only two accessible parking spaces, but given a total space count of 70 there should be 3 accessible spaces. Because the building is used as a senior center, we recommend 10% of spaces be accessible.

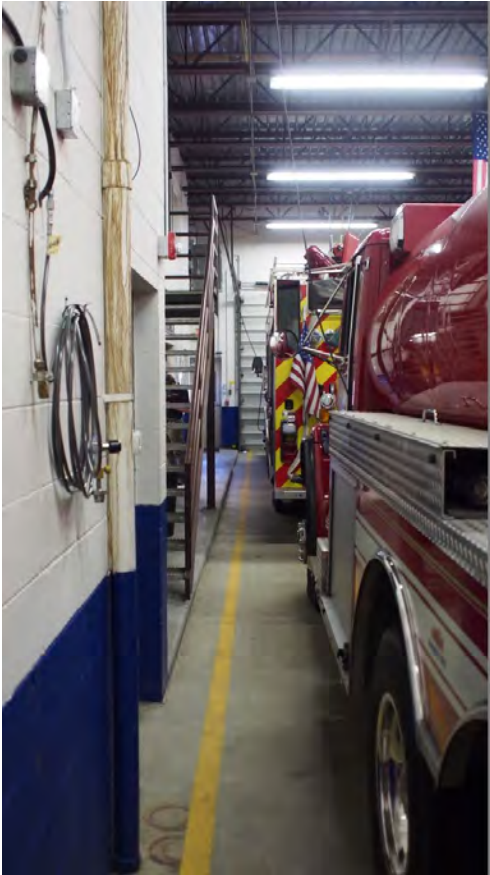
Figure Q.4a

3. There is insufficient glass in the apparatus doors to be able to see what is directly outside the doors before opening them.
4. There is insufficient space to fit fire apparatus comfortably within the building. The apparatus is parked very close to the side walls, very close to the rear walls, and very close to each other. This proximity increases the risk that a firefighter will be injured by moving apparatus, whether it is backing into the station or whether it is responding while firefighters are getting onto the rig.
