# Fire Station #2 Assessment and Capital Plan

## AA. Building Description

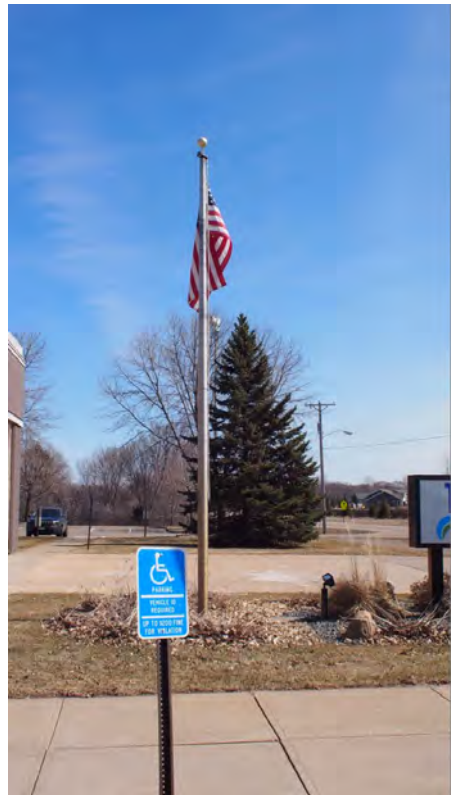
Figure BB.4.1

12. The asphalt walking path is in good condition.
4. Landscaping and Site Elements
  1. Plantings were not observed due to the time of year.
  2. The flagpole is in good condition with cosmetic discoloration at the base.

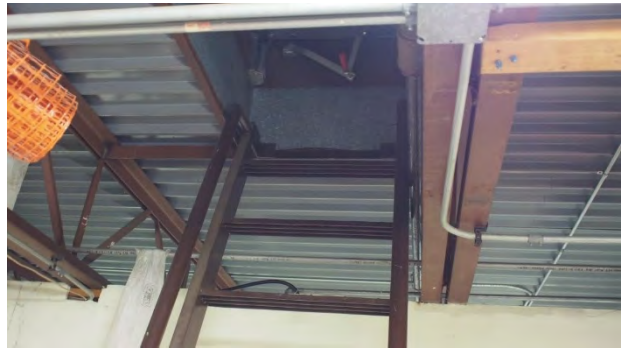
Figure FF.3

- 1. There is no elevator in the building.
- 2. A mezzanine is accessed from a steel stair.
- 3. The roof hatch is accessed from a ships ladder.
- 4. The hose tower platform is accessed via a ladder.

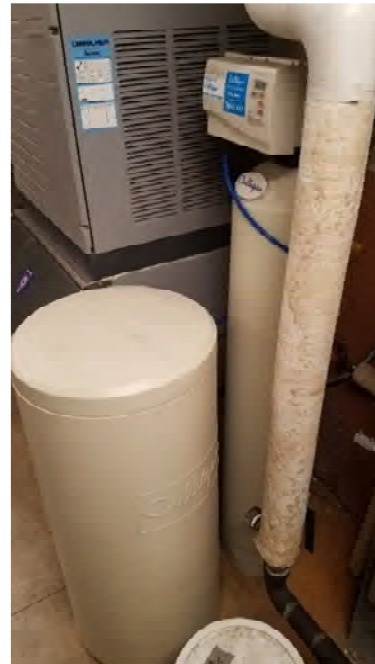
Figure HH.2

- 1. Water meter is located in the Shop.
- 2. The Water softener appeared in good condition, no date of install was identified. We do not expect replacement to be necessary in the next five years.

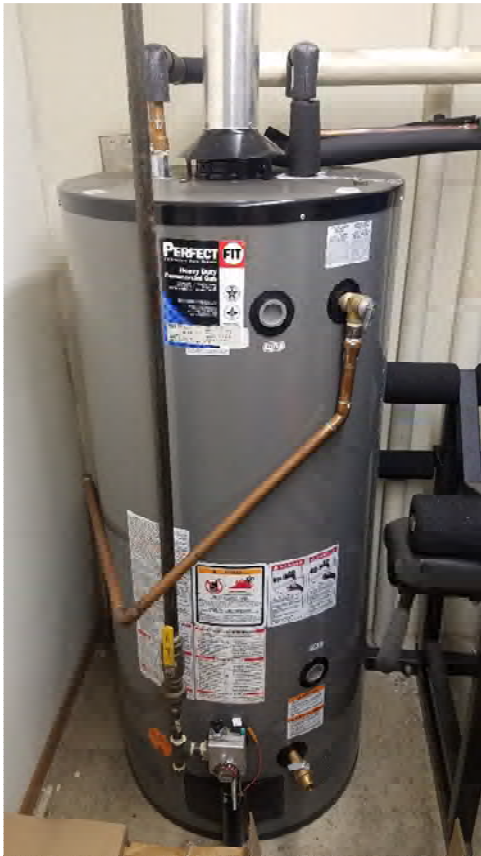
Figure HH.3

- 3. The 75-gallon Perfect Fit water heater on the mezzanine is in good condition and in the middle of its useful life. We estimate that replacement will not be needed for another 5-10 years.

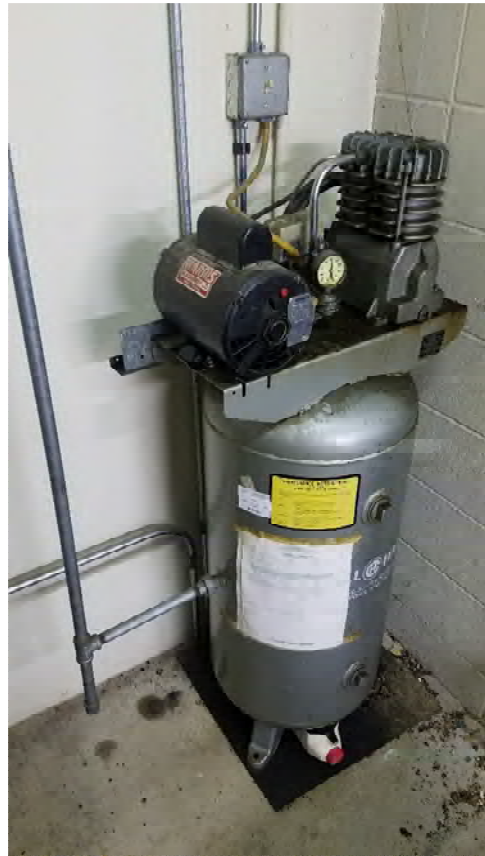
Figure HH.4

- 4. The Howard air compressor is past its useful life and should be replaced in the next 1-5 years.
- 5. Sanitary piping was not observed.
- 6. Fixtures

| Item | Estimated<br>Construction<br>Cost* | Recommended Time Period | | | |
|--|---|---|---|---|---|
| Replace air compressor | \$ 2,500 | | | | X |

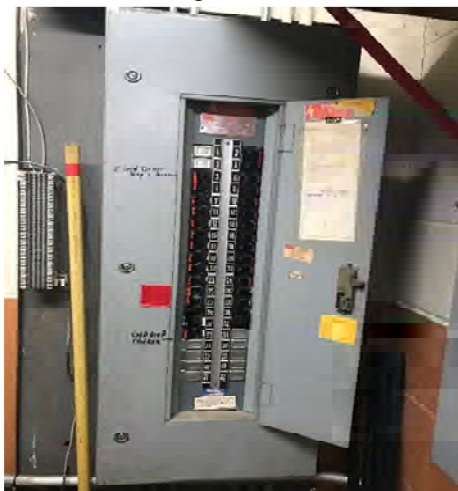
Figure JJ.4

1. The service is fed from pad mounted transformer in the back of the building.
2. Electric meter is shared with the City Hall and located in the back of the building.
3. The fire station panel is fed from 400A, 208/120V service in the City Hall area.
4. A 100 Amp three-phase main panel is located in the Shop.
  1. The panel powers all lighting fixtures, mechanical equipment, and receptacles in the apparatus area.
  2. The electrical panel and all circuit breakers appear to be in good working condition.
5. There is a junction box in the Office without a cover plate.
6. Outlets in the Apparatus Bays appear to be without Ground Fault Interrupt

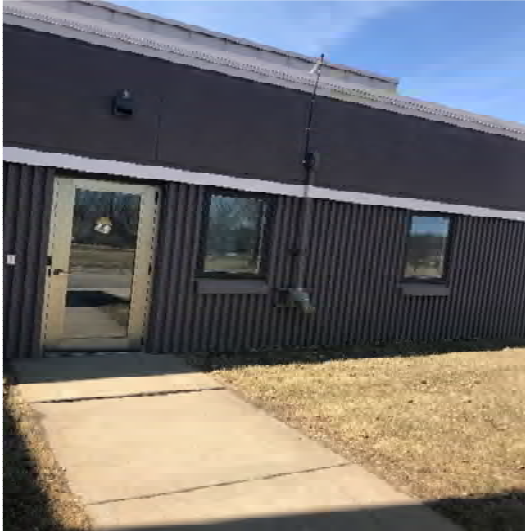
Figure KK.1

1. There is a connection for a portable generator that backs up the entire building.
2. Emergency battery operated lights are located above exit doors.

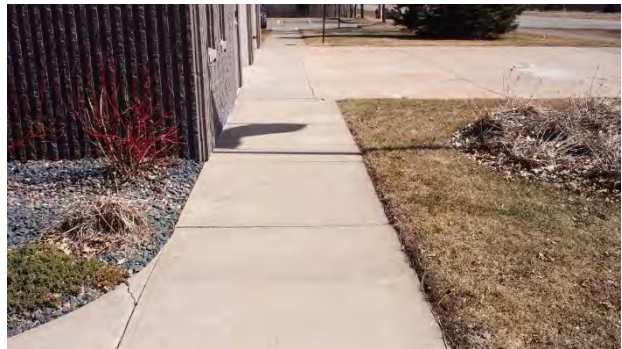
Figure OO.2

1. There is no sidewalk connection between the public path and the front door.
2. There are no truncated dome detectable warnings where the apparatus apron crosses the sidewalk.

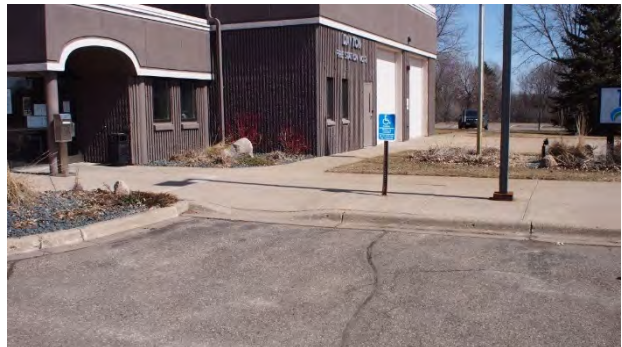
Figure OO.4

3. There are no truncated dome detectable warnings at curb ramps.
4. The accessible parking spaces are not correctly painted.
5. Doors throughout the building have knob hardware instead of lever hardware.
