# Dayton Water System Update

23 February 2021

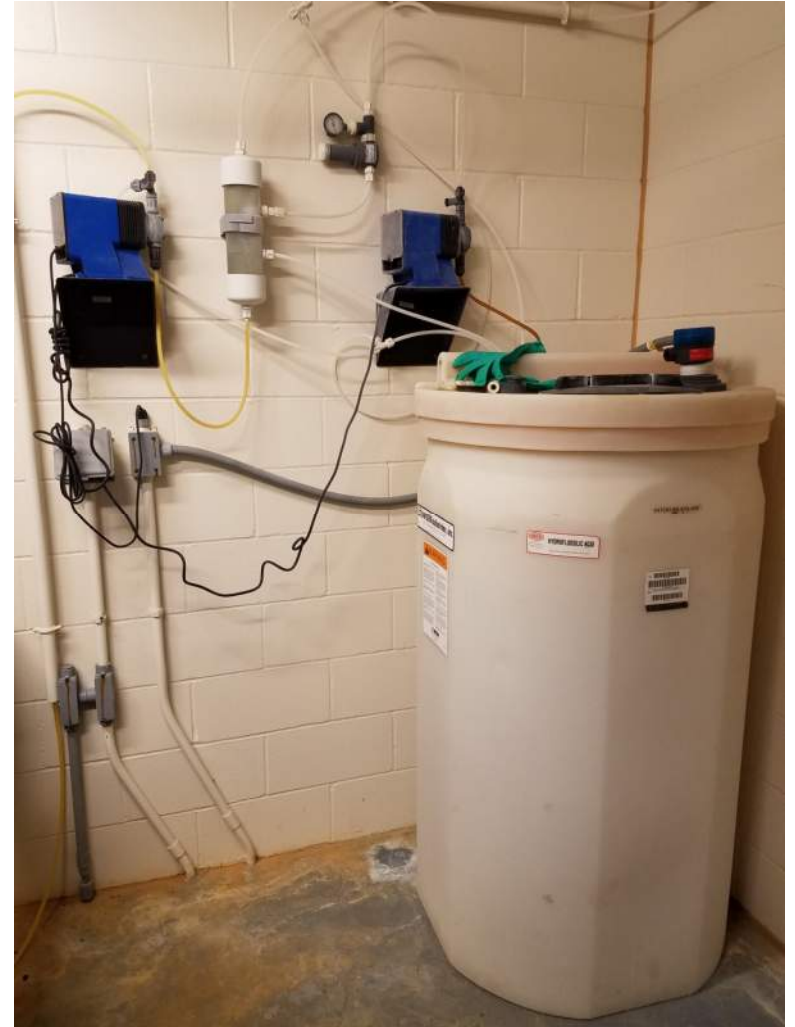
## 2018 Well 2 Improvements

- Increase phosphate and chlorine dosages
  - Optimize phosphate product being fed
- Small improvements to infrastructure
  - Chemical Feed Improvements
    - Mixing
    - Monitoring
  - Additional Chemical Feeds
  - Water Tower Mixing and standpipe

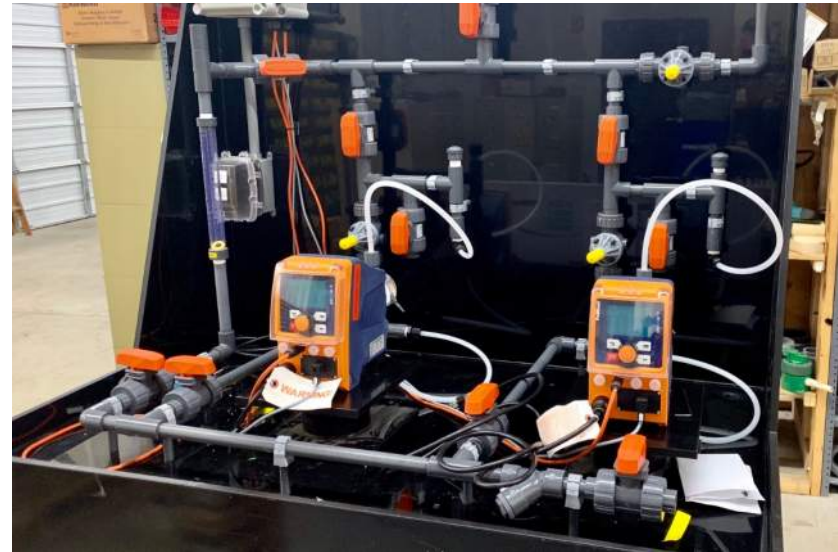
# New polyphosphate skid

- Installed in December 2018
- Ability to vary chemical feed with flow rate and water quality
- Provides redundancy
- More accurate metering and tracking of phosphate dosed and used

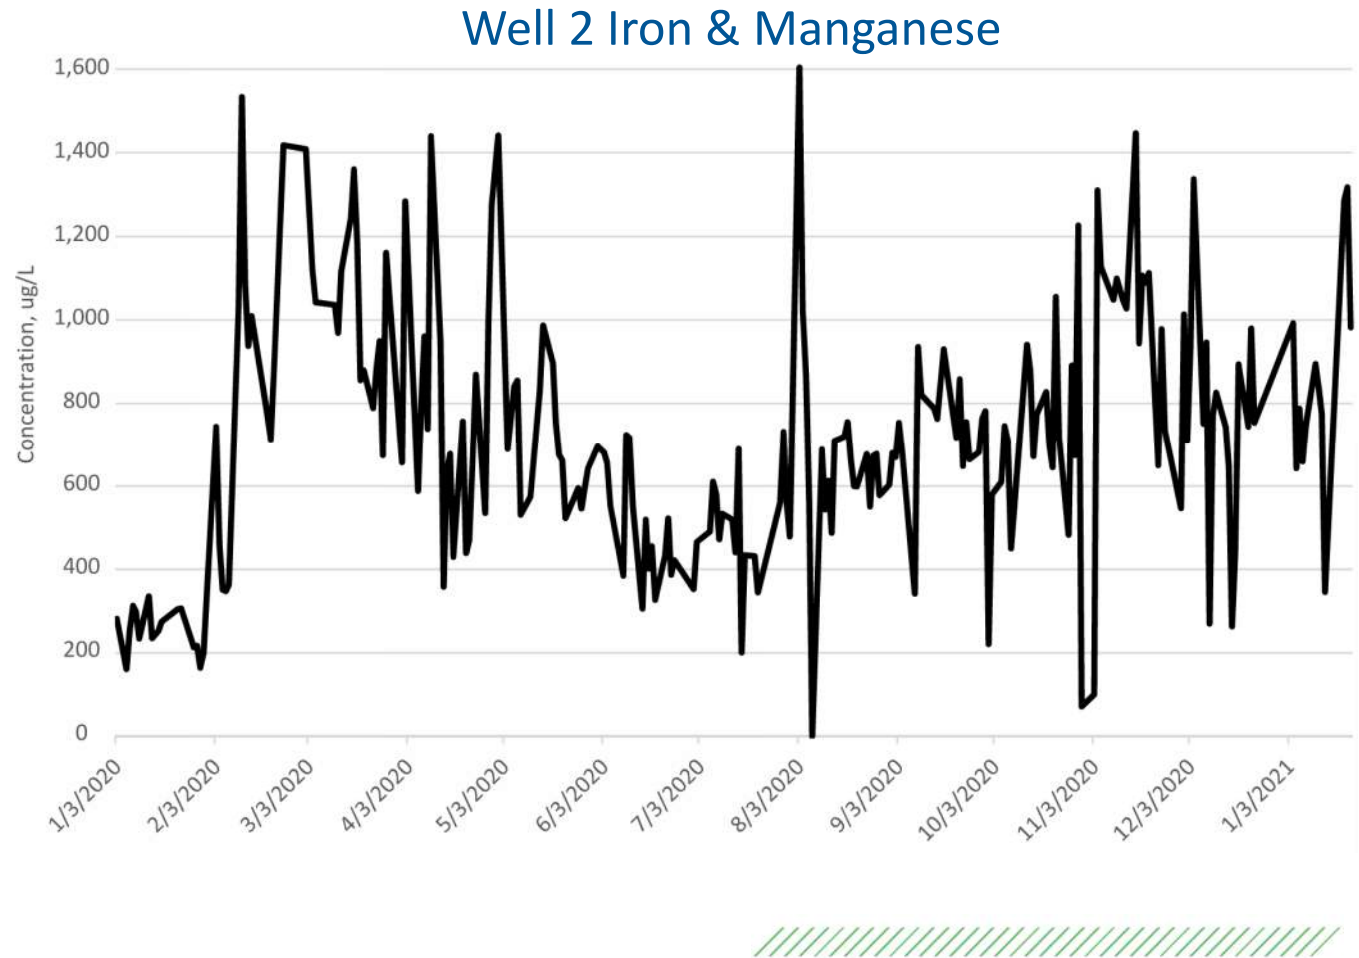
# Implemented Regular Water Quality Testing Program

- Testing for iron, manganese, chlorine, sulfate, and ammonia.
- Historical trends

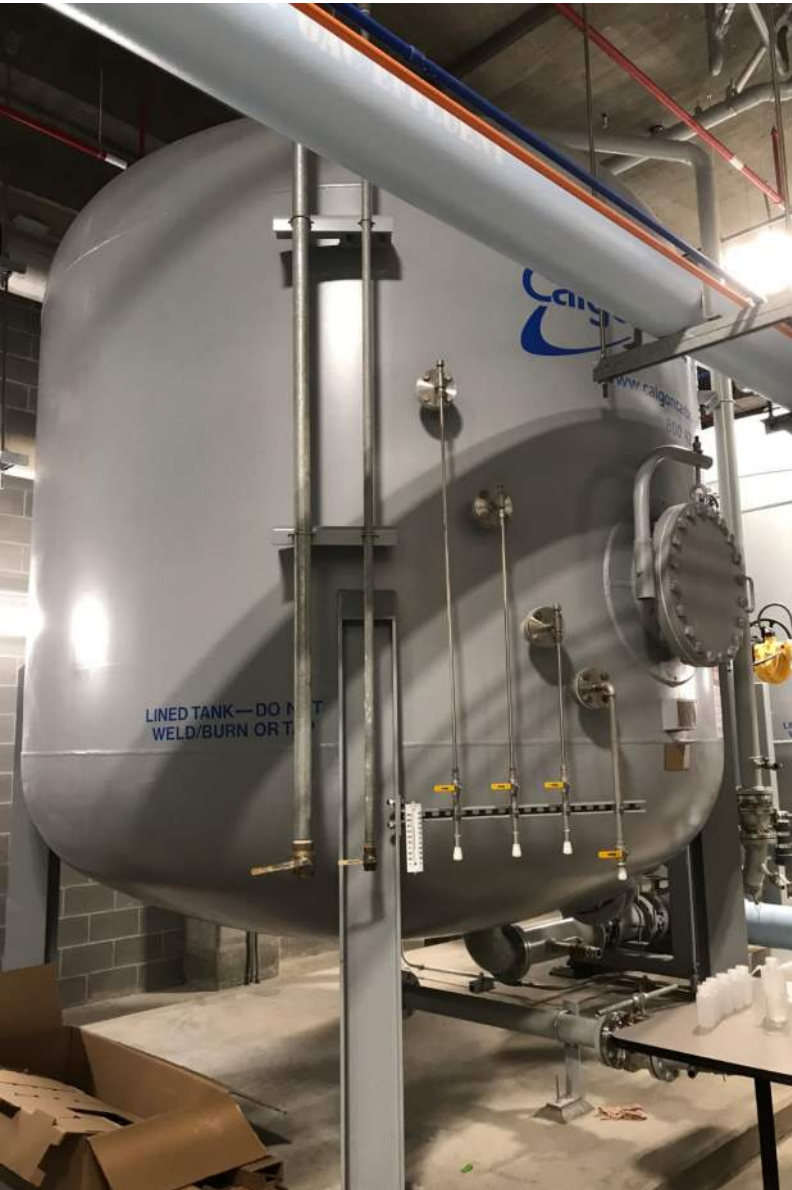
## Oxidation & Filtration

- Oxidize Iron with Chlorine
  - Wellhouse will have Chlorine technology for disinfection.
- Fast Iron Reaction – Dissolved -> Solid State
- Filter out with media filter
  - Potentially use Greensand for Manganese removal
- Significant Questions
  - What to do with the Backwash? Location of Sewer? Backwash disposal versus sludge disposal?
  - Size of Filters? Diameter ~8-12 feet
