Diamond Creek Subwatershed Assessment Report

March 23, 2022

City of Dayton

Stantec

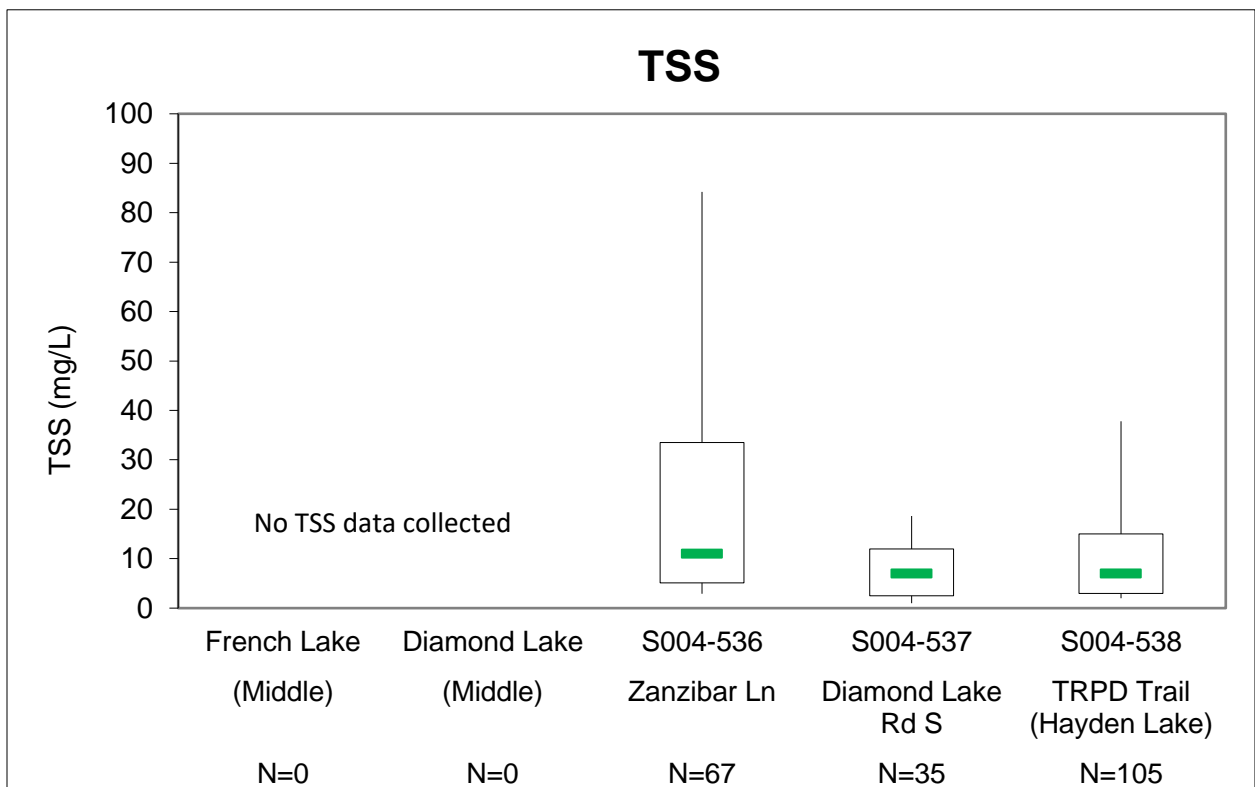
Figure A-1. Diamond Creek SWA Study Area lake and stream TSS monitoring data (2007-2012). Boxplots for the in-pool TSS (Total Suspended Solids) concentration of each study lake. The upper and lower edge of each box represent the 75th and 25th percentile of the data range for each site. Error bars above and below each box represent the 95th and 5th percentile of the dataset.

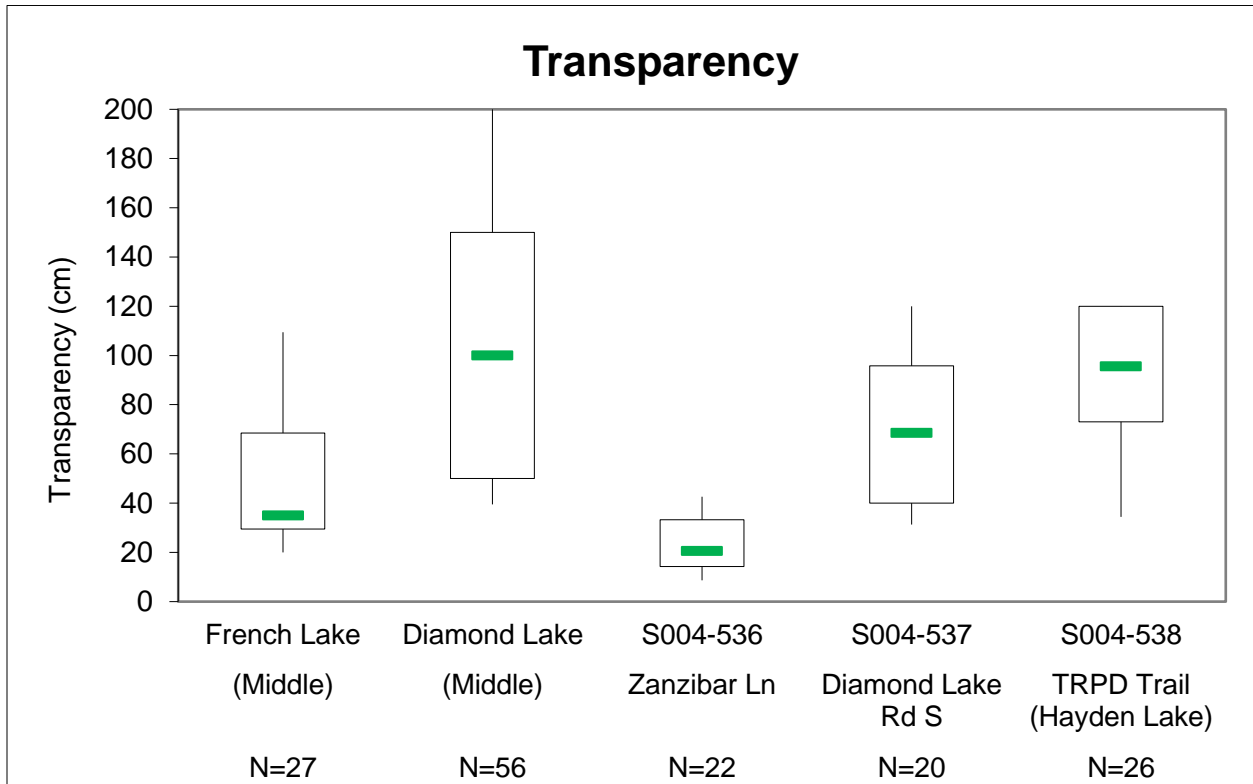
Figure A-2. Diamond Creek SWA Study Area lake and stream transparency monitoring data (2007-2012). Boxplots for the in-pool transparency (cm) of each study lake. The upper and lower edge of each box represent the 75th and 25th percentile of the data range for each site. Error bars above and below each box represent the 95th and 5th percentile of the dataset. The green dash is the median concentration of all data collected.

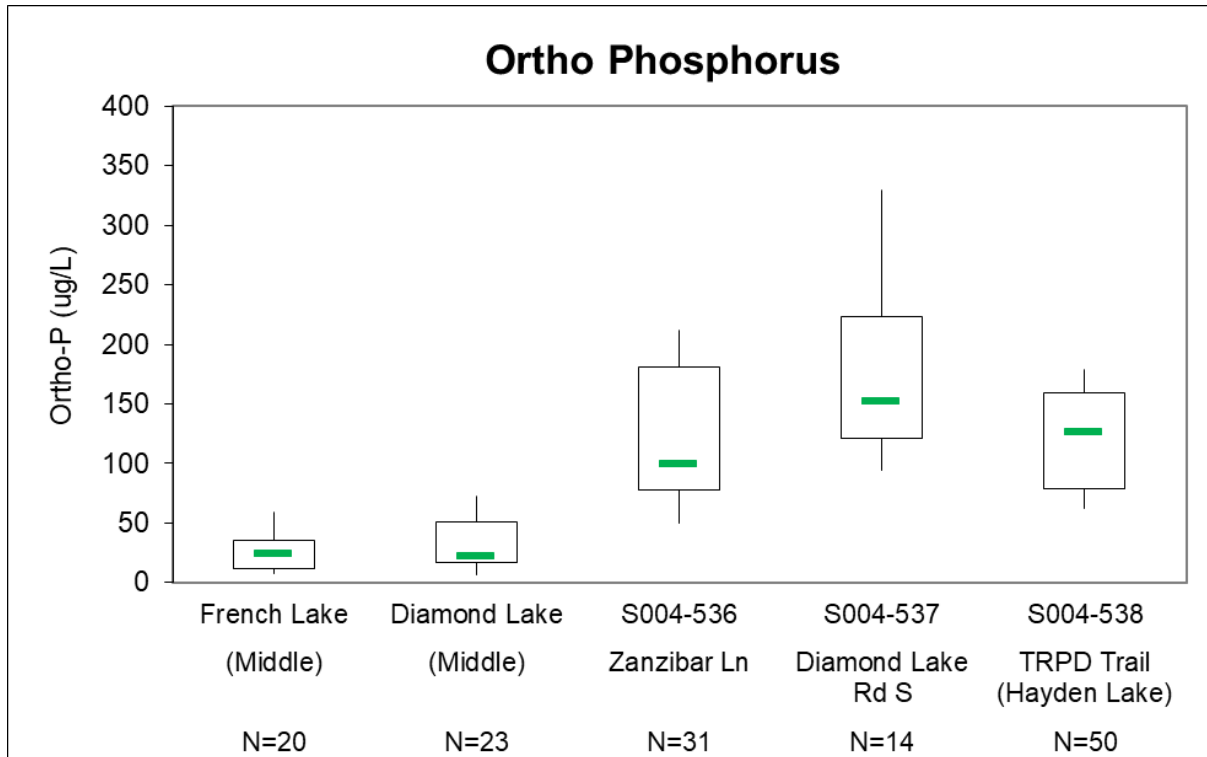
Figure A-4. Diamond Creek SWA Study Area lake and stream summer orthophosphate monitoring data (2007-2012). Boxplots for the in-pool Ortho-Phosphorus (Ortho-P) concentrations in each of the study lakes. The upper and lower edge of each box represent the 75th and 25th percentile of the data range for each site. Error bars above and below each box represent the 95th and 5th percentile of the dataset. The green dash is the median concentration of all data collected.

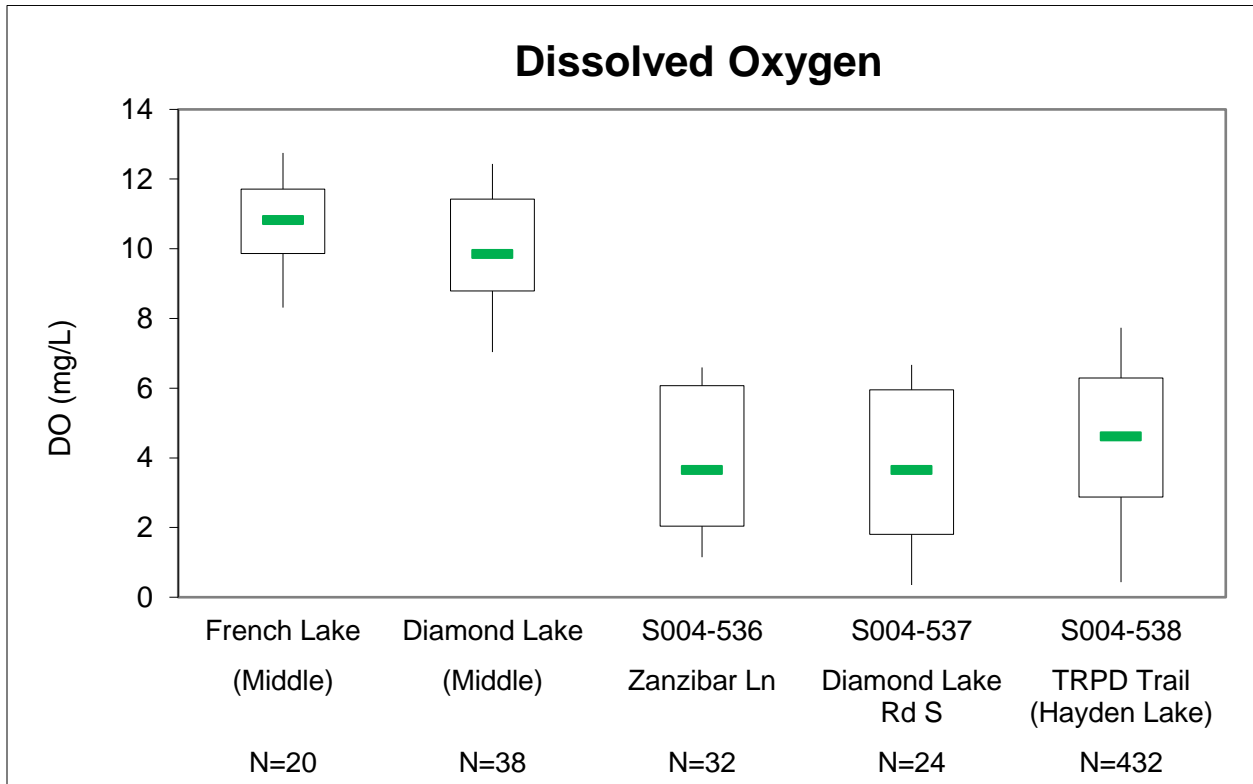
Figure A-6. Diamond Creek SWA Study Area lake and stream summer dissolved oxygen monitoring data (2007-2012). Boxplots for the in-pool Dissolved Oxygens (DO) concentrations for each study lake. The upper and lower edge of each box represent the 75th and 25th percentile of the data range for each site. Error bars above and below each box represent the 95th and 5th percentile of the dataset. The green dash is the average concentration of all data collected.

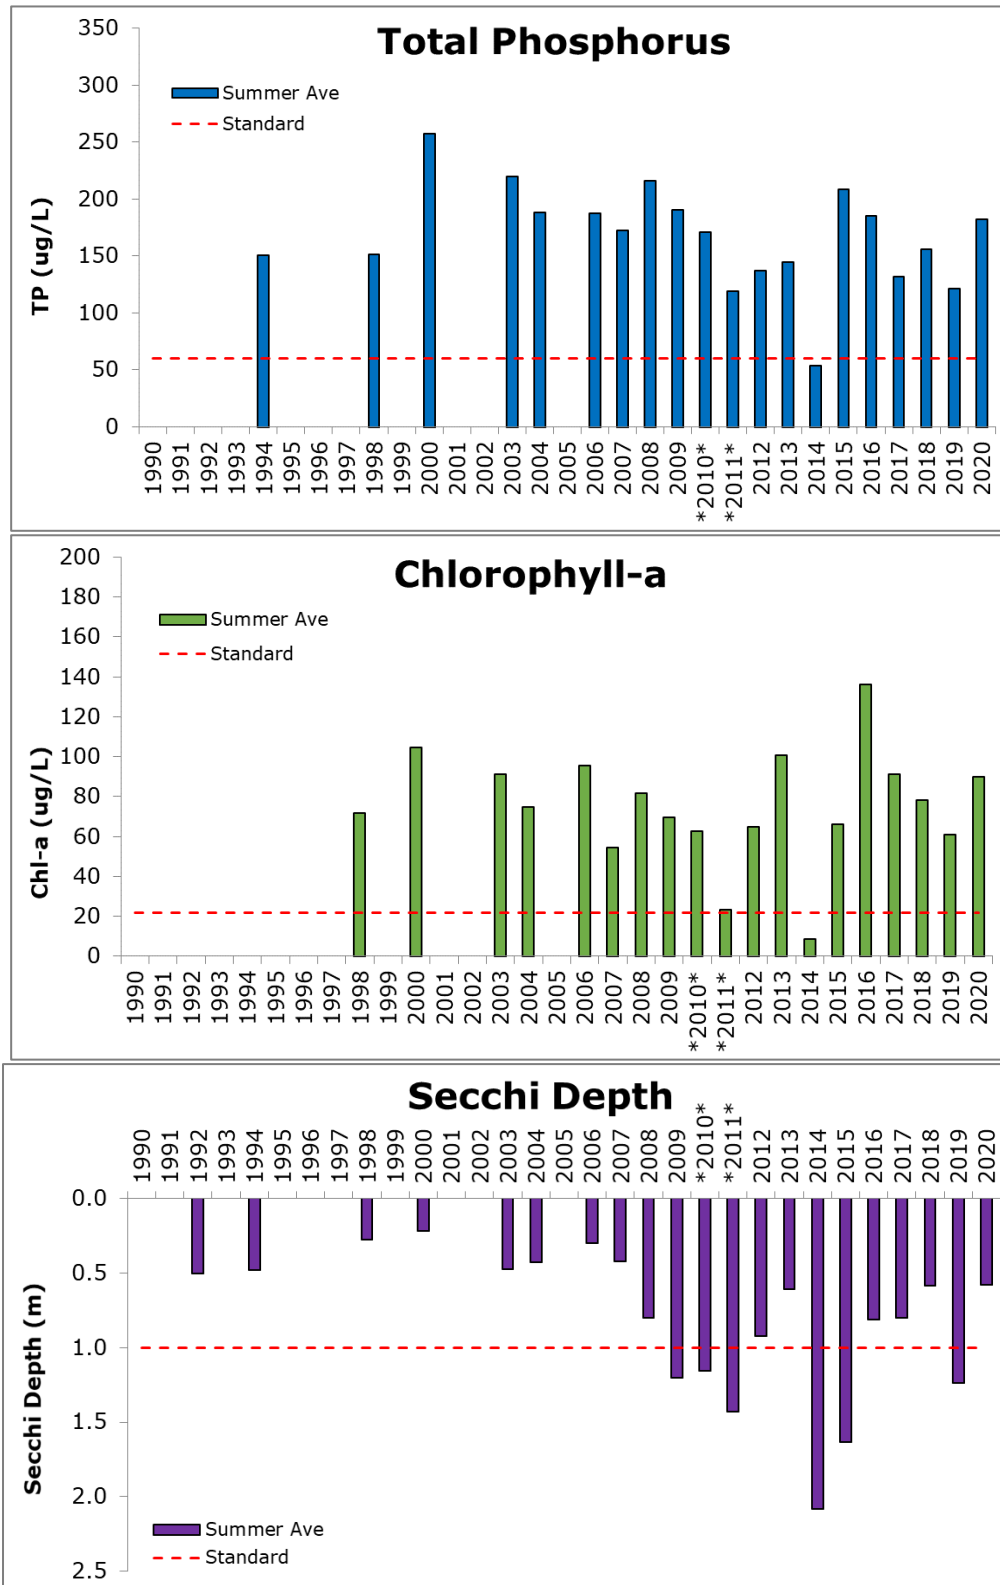
Asterix (*) denotes years used to develop the Diamond Lake TMDL.

Figure C-1. Diamond Lake summer average TP (top), chlorophyll-a (middle), and Secchi depth (bottom).

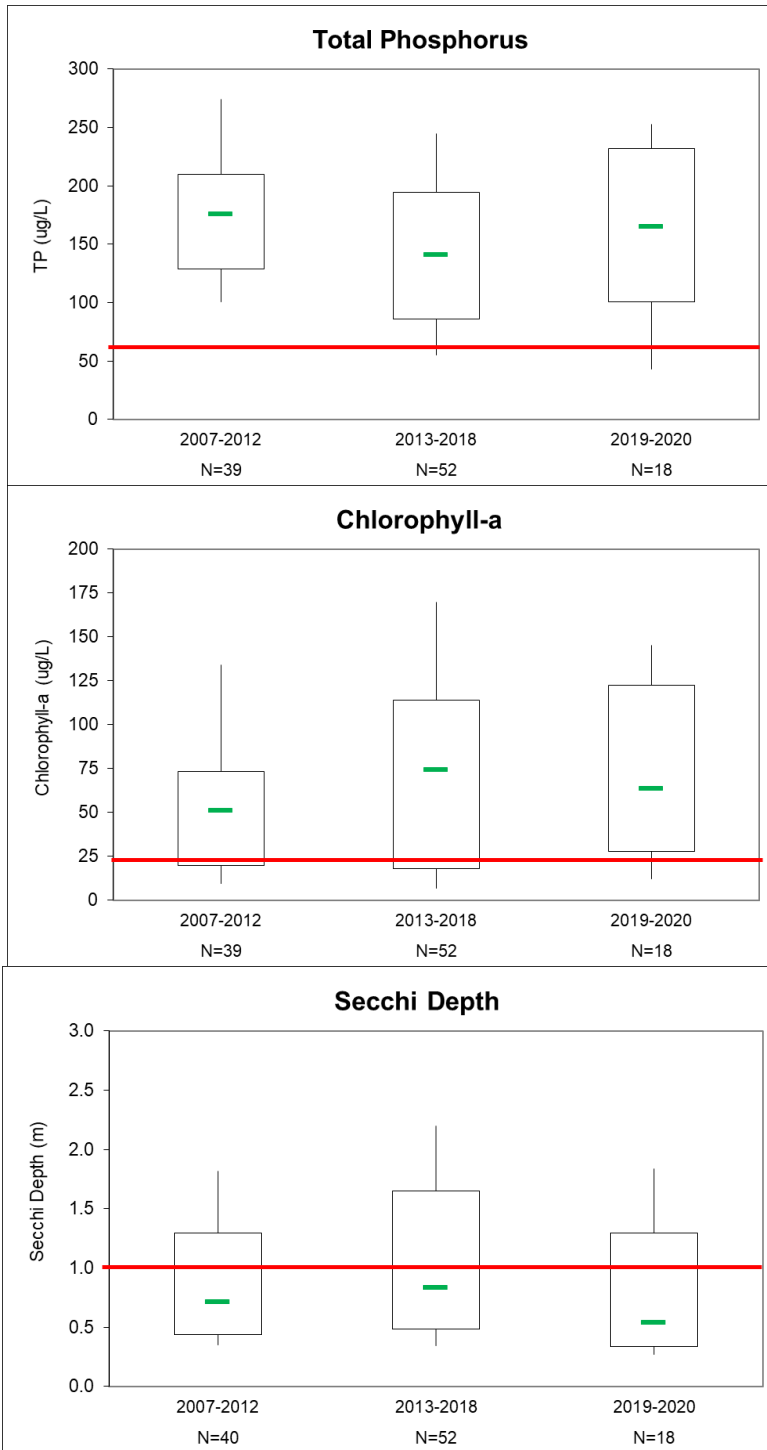
Figure C-3. Diamond Lake water quality monitoring before CLP management (2007-2012), during Endothall treatments (2013-2018), and during Fluridone treatments (2019 and 2020). The upper and lower edge of each box represent the 75th and 25th percentile of the data range for each site. Error bars above and below each box represent the 95th and 5th percentile of the dataset. The green dash is the average concentration of all data collected. The red line represents the shallow lake water quality standards.

Although CLP FOO decreased significantly in 2019 and 2020 as a result of the Fluridone treatments, water quality parameters did not show a significant response. Figure 3 contains a series of box plots showing monitored TP, chlorophyll-a, and Secchi depth for three different time periods before and during CLP treatments: 1) six years prior to endothall treatments (2007 through 2012); 2) six years of endothall treatments (2013 through 2018); and 3) two years of Fluridone treatments (2019 and 2020). These data suggest TP concentrations and Secchi depth have remained relatively consistent across each period of CLP management. Chlorophyll-a, on the other hand, has shown a slight increase and a higher incidence of nuisance algae blooms (i.e., chl-a levels that exceed 50 µg/L) since treatments began in 2013.
