Fire Station #1 Assessment and Capital Plan

A. Building Description

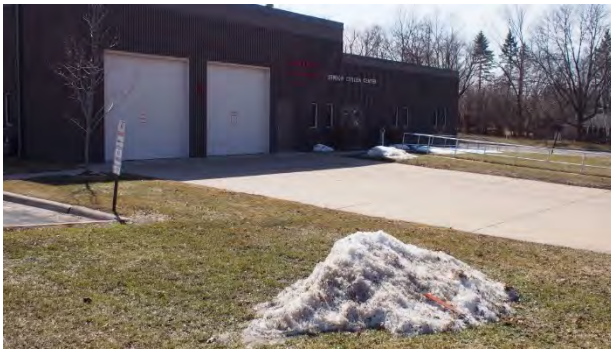
Figure B.1.1

1. Topography
 1. The site slopes from the south (back) side towards the north (street side) away from the Crow River and slightly from east to west. The low point is at the northwest corner.
 2. The building finished floor elevation is approximately 3' higher than Dayton Street and approximately 1' higher than the parking lot.
 3. There is an embankment between the parking lot and Division Street that prevents egress from the site on the East side.
2. Storm Water Drainage
 1. The Senior Center roof drains through two scuppers on the west elevation, which daylight to grade.

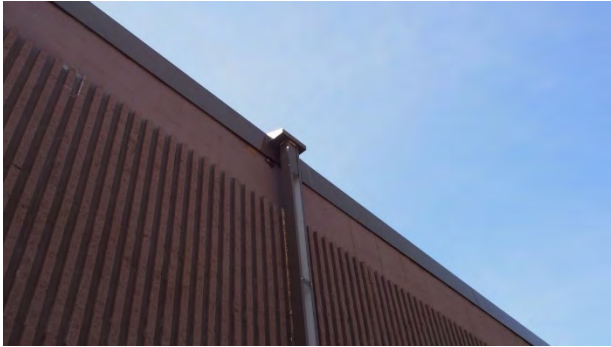
Figure B.2.2

2. The Fire Station roof drains through two scuppers on the east elevation, which daylight to grade.
3. The storm sewer inlet at the northwest corner of the site (low point) is in good condition.

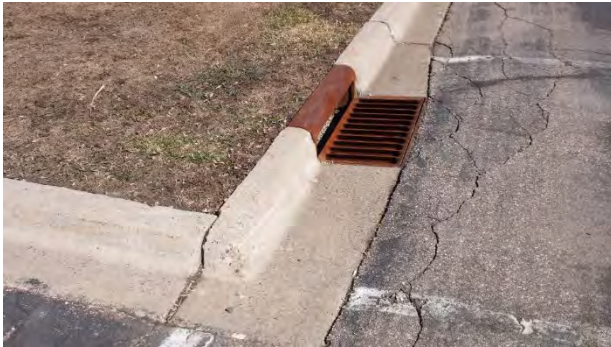
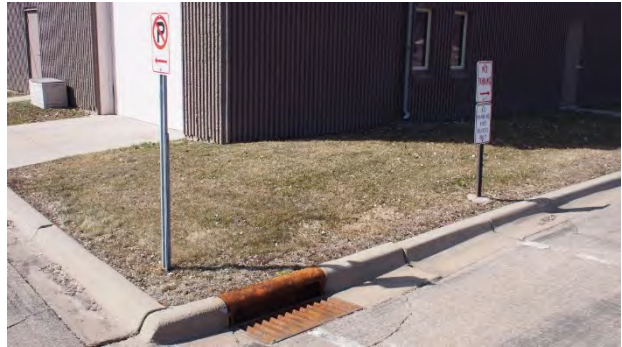
4. The storm sewer inlets at the southeast and southwest corners of the building (draining the rear parking area) are in good condition.
3. Paving and concrete

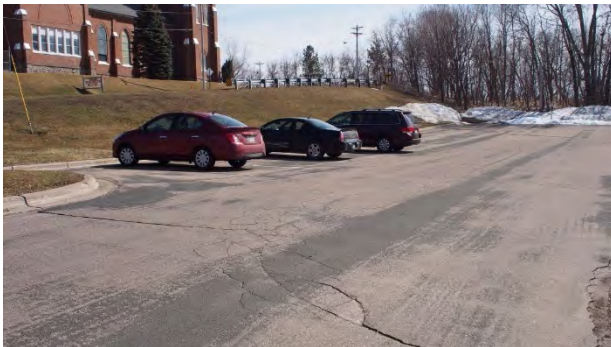
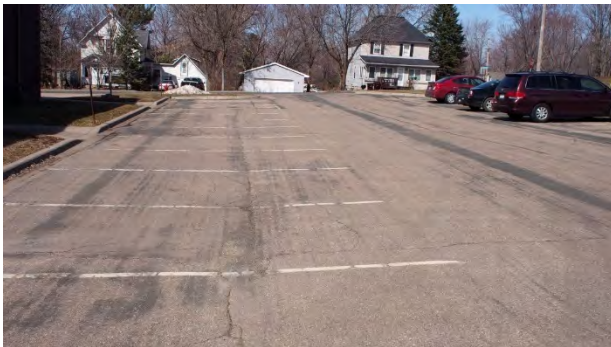
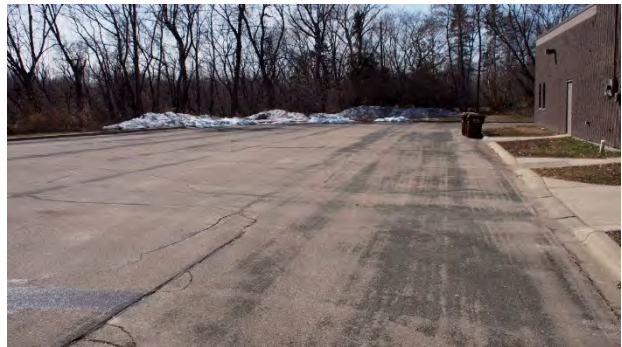
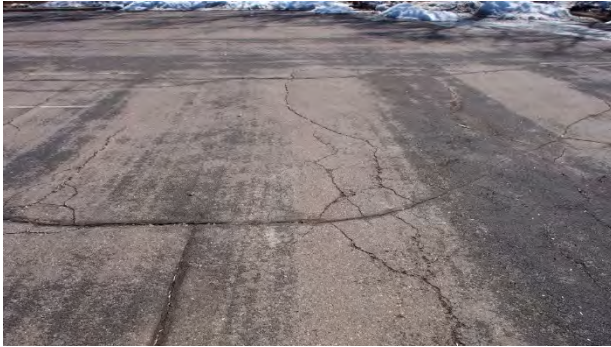
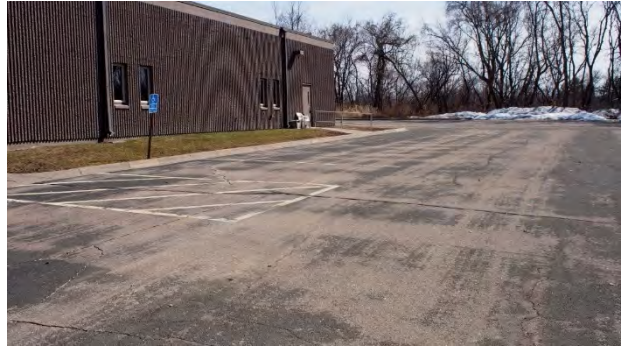
1. The asphalt parking lots are in poor condition. We estimate replacement will be critical within 10 years.
 2. The asphalt in Dayton Street at the response apron is in poor condition. We recommend cutting it out and replacing.

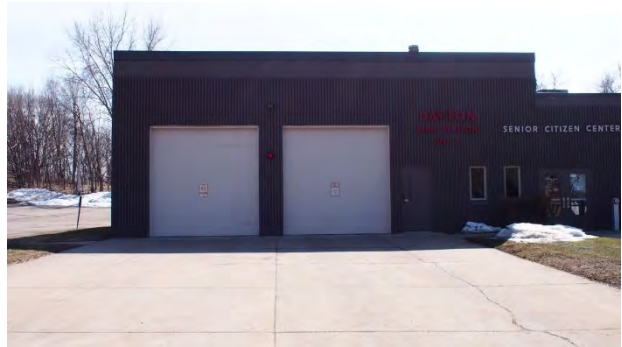
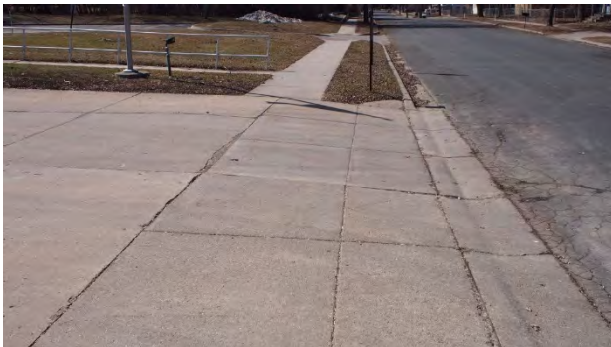
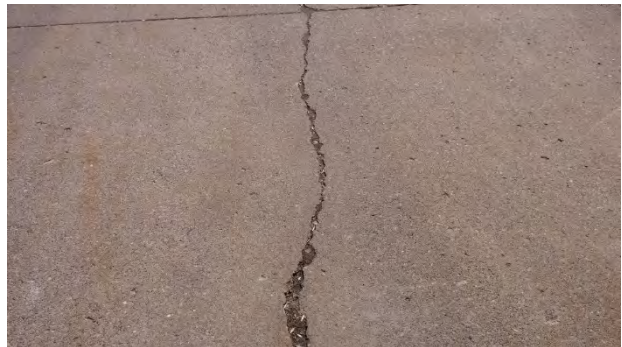
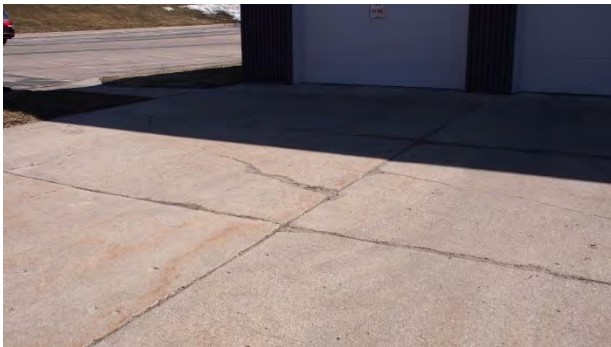
3. The concrete response apron is in poor condition with major cracking and spalling. We estimate replacement will be critical within 10 years.
 4. The concrete return apron is in good condition.

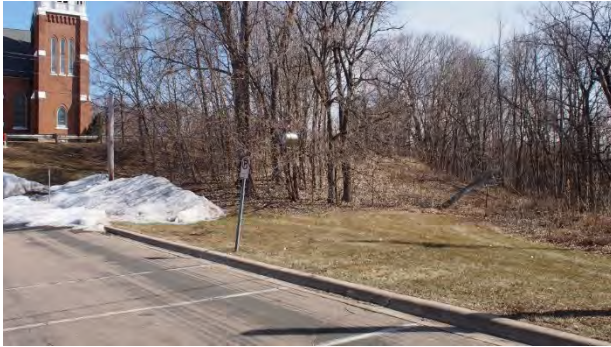
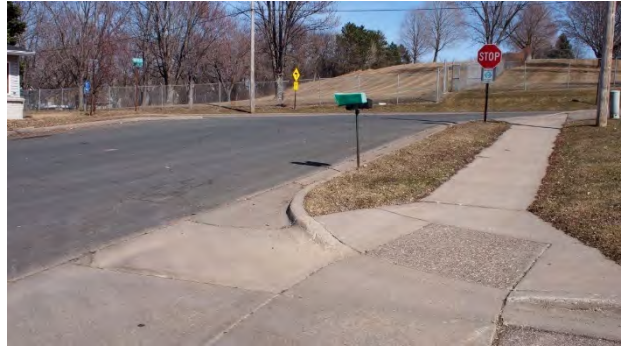
5. The concrete curbs and gutters are in generally good condition with some areas showing superficial scrapes and abrasion.
 6. The concrete parking lot entry on the east side is in good condition.

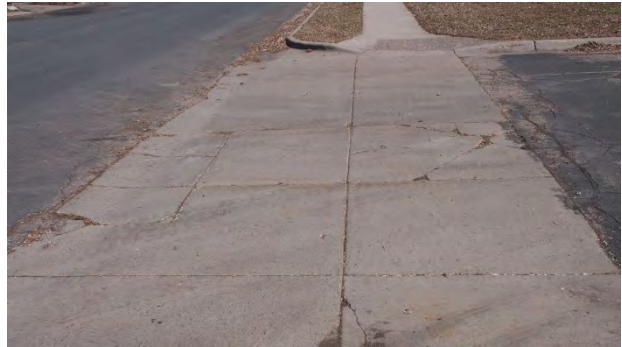
Figure B.3.7

7. The concrete parking lot entry on the west side is in poor condition and should be replaced.
 8. The concrete sidewalks are in generally good condition.

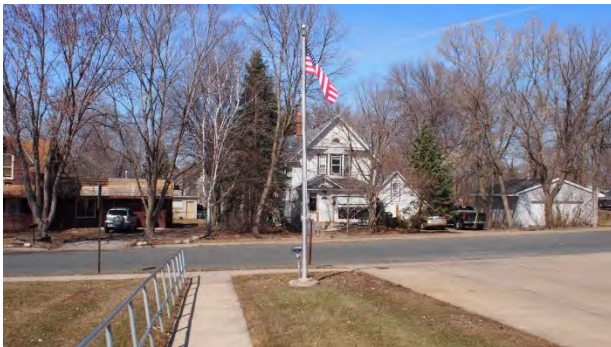
Figure B.4.2

1. Plantings were not observed due to the time of year.
 2. The flagpole is in good condition.
 3. The handrails along the sidewalks are leaning and should be removed and re-set in new foundations.

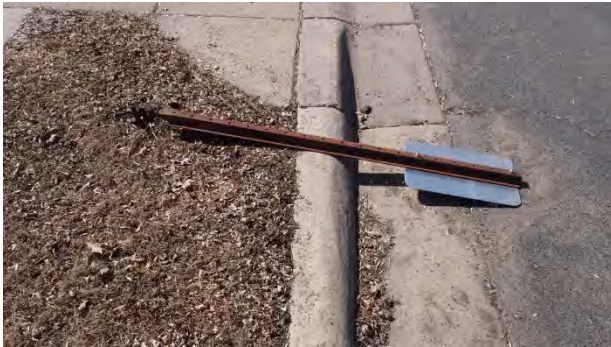
Figure B.4.4a

4. The no parking and reserved parking sign poles are broken off or leaning and should be removed and re-set with new concrete foundations.
5. Water service entrance was not observed.

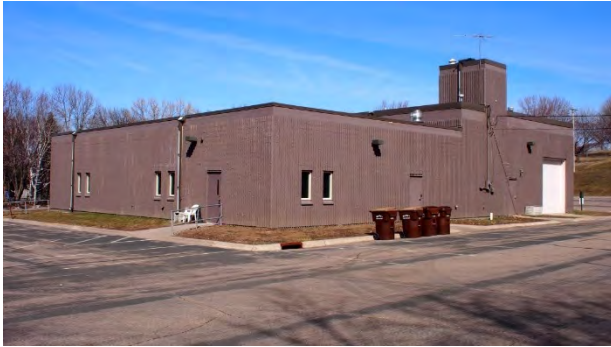
Figure B.11

8. Sanitary Sewer Utility was not observed.
9. Storm Sewer inlets are located at the southeast and southwest corners of the building and at the northwest corner of the site.

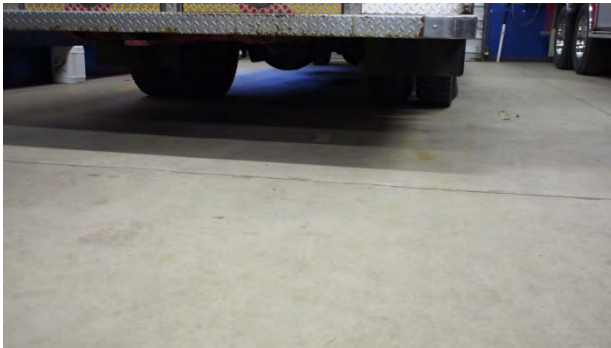
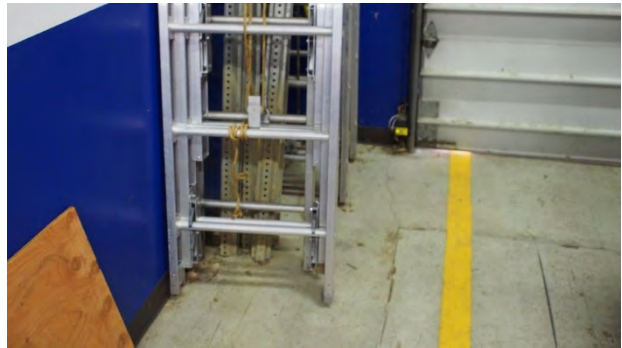
1. The foundation appears to be in good condition as there is no evidence of building settlement.
2. The slab-on-grade, where visible, appears to be in generally good condition with minor cracking and superficial staining.
3. The exterior bearing walls are stacked-bond concrete masonry and are generally in good condition.
