# Fire Station #2 Assessment and Capital Plan

## AA. Building Description

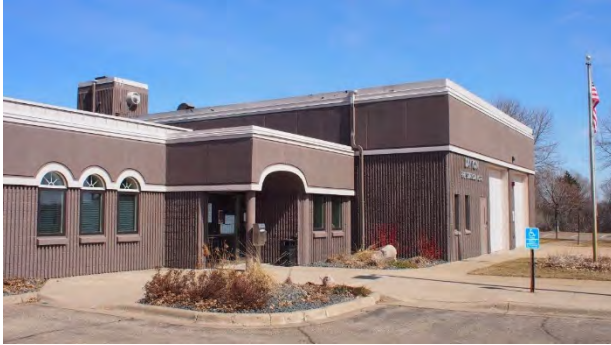
Figure AA.1.1

1. Past and Current Use
  1. The Fire Station was purpose built in the 1980's. The City Hall was added in 1990. Only the Fire Station portion of the building was reviewed.
2. Location
  1. The address is 12260 South Diamond Lake Road.
  2. The building is located in the NE portion of the City of Dayton, east of Pineview Lane.
3. Size
  1. The total building has a footprint of approximately 10,000 square feet. The fire department has sole occupancy of approximately 3,450 square feet with a mezzanine of approximately 1,000 square feet.
  2. The site is within the boundaries of Central Park.

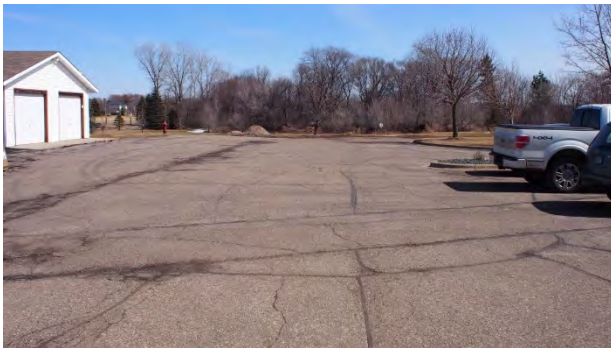
Figure BB.1.1

1. Topography
  1. The site is relatively flat with a general downward slope from south to north. The bulk of the park is a few feet lower than the building pad.
  2. The low spot is at the northwest corner of the parking area.
2. Storm Water Drainage
  1. The Fire Station roof drains through two scuppers on the east elevation, which daylight to grade, and two scuppers on the west side, one of which daylights to grade and the other which empties onto the City Hall roof.
  2. The City Hall roof drains through three scuppers on the west elevation, which daylight to grade.

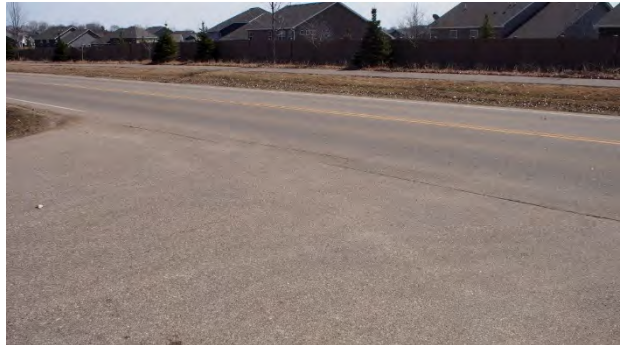
Figure BB.3.1

3. Paving and concrete
  1. The asphalt paving in South Diamond Lake Road right-of-way is in good condition.
  2. The concrete portion of the response apron is in bad condition and should be replaced.

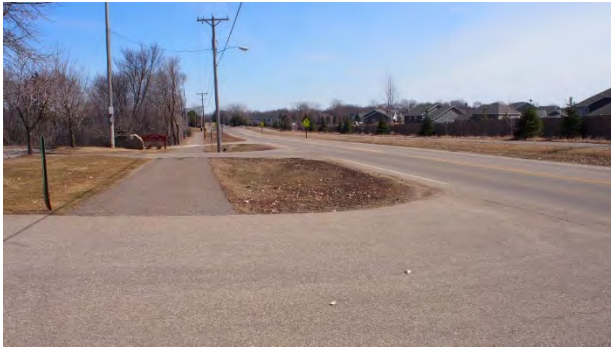
Figure BB.3.3

3. The asphalt portion of the response apron is in good condition.
  4. The asphalt at the public parking lot is in average condition and shows signs of repair and maintenance. We recommend treating the cracks and recoating within five years to improve the longevity of the paving.

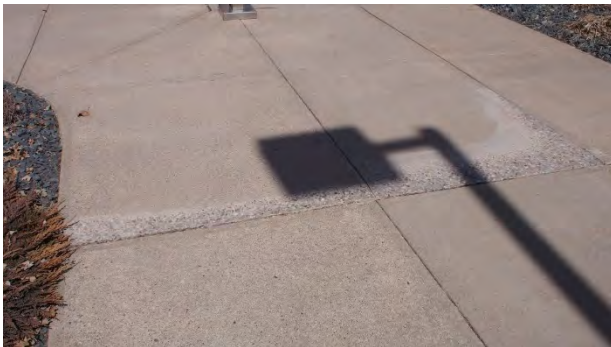
Figure BB.3.5a

5. The concrete patio by the public entrance is in average condition with some cracking and evidence of grinding.
  6. The concrete sidewalk west of the building is in poor condition with spalling occurring at the control joints.

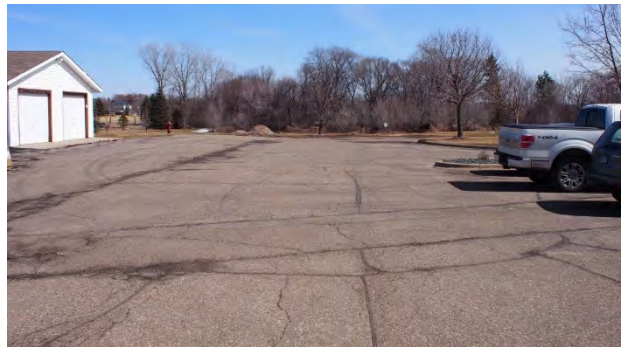
Figure BB.3.7a

7. The asphalt parking lot east and north of the building is in bad condition and is past the point of repair. Large sections potholes have formed and plows are accumulating chunks of paving in the corners of the lot. We recommend replacement. We recommend concrete be used at locations where apparatus turn.

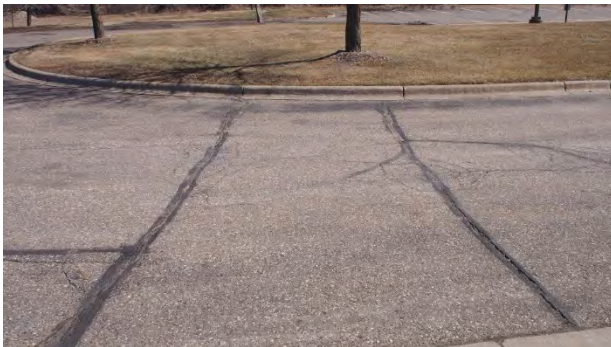
Figure BB.3.8

8. The asphalt portion of the return apron is in poor condition and should be replaced.
  9. The concrete portion of the return apron is in average condition.

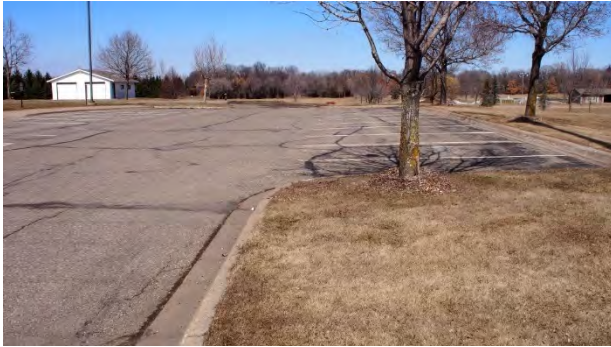
Figure BB.3.10a

10. The curb and gutter at the firefighter parking lot is in generally average condition with some areas of advanced degradation.
  11. The concrete sidewalks north and east of the building are in average condition.

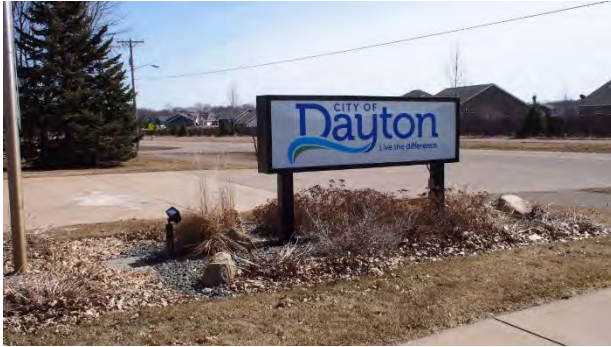
Figure BB.4.3

3. The monument sign is in good condition.
  4. The bollards at the rear apron are starting to rust and are not sealed at the base. We recommend scraping any loose paint and rust and recoating with a rust-inhibiting paint, then caulking at the base with sealant to prevent cracking of the concrete.

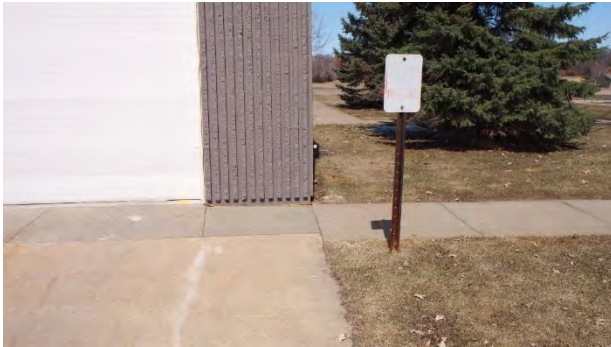
Figure BB.4.5a

5. The no parking signs at the front apron are faded or missing. We recommend replacement.
5. Water service entrance was not observed.
  1. There is a fire hydrant at the northeast corner of the parking lot.
